FEASIBILITY STUDY

ARKANSAS STATE CRIME LAB

FINAL

09/30/2021

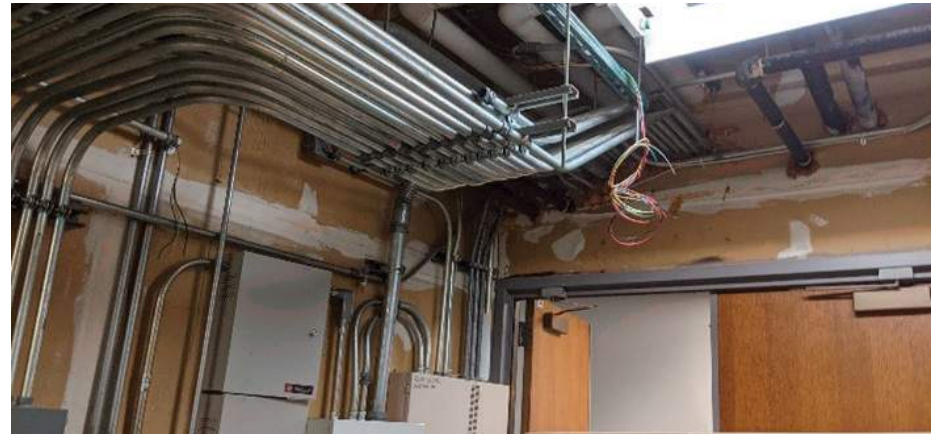
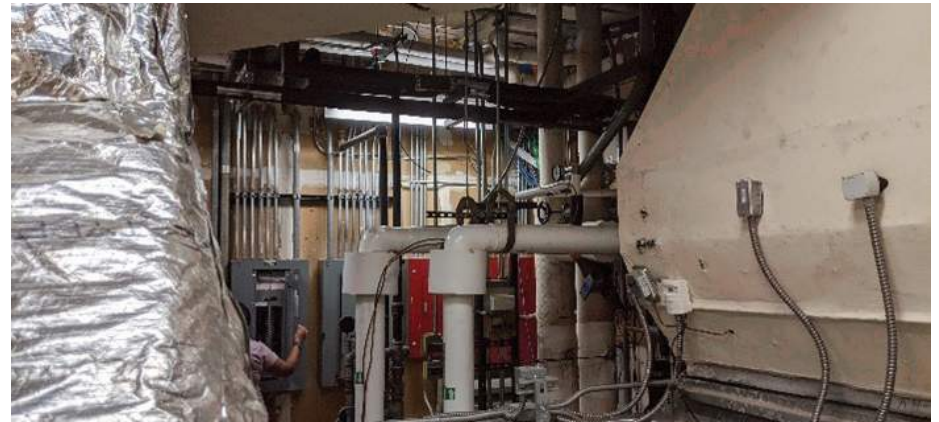
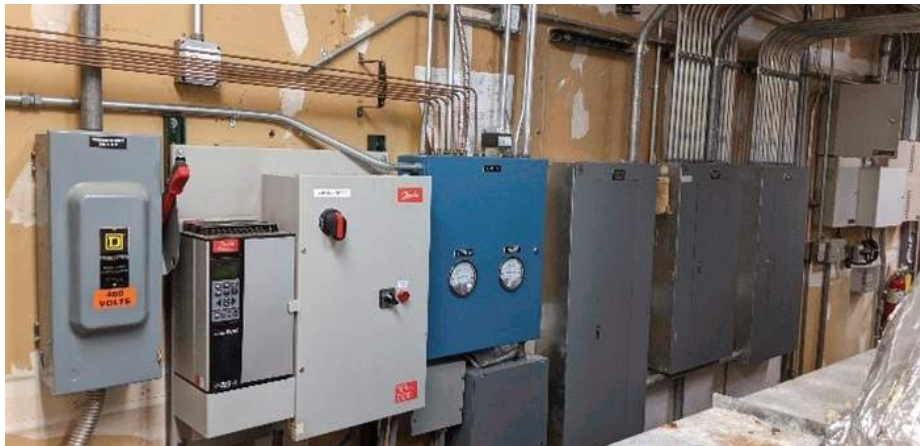
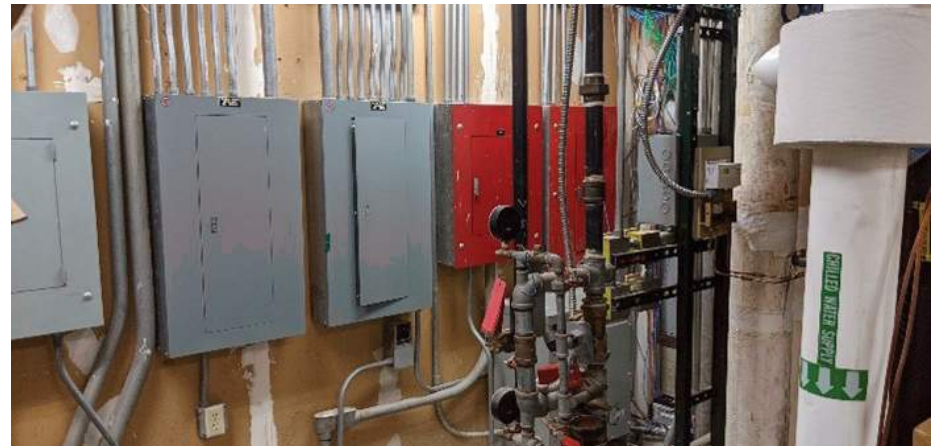
Images: Proximity issues of electrical panels and distribution from mechanical, plumbing, and fire protection systems in MEP rooms.

The collocation of the central plant with building electrical services is problematic. A significant water leak, flooding, or large natural gas leak has the potential to shut down building operations including the emergency power system. Increasing chiller sizes and capacities to meet the cooling demand only makes this condition worse and reduces already tight clearances. Overhead piping and ductwork in proximity to electrical equipment does not 2017 NEC requirements and trying to remedy this condition will be costly and, in some cases, not practical.

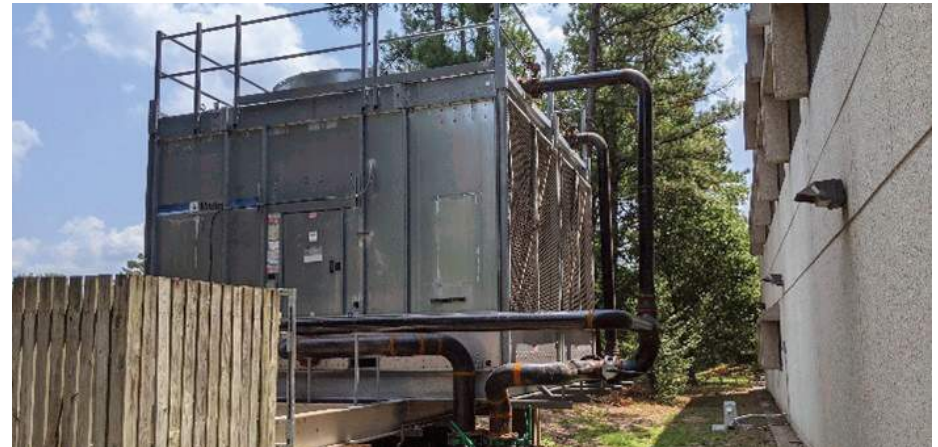
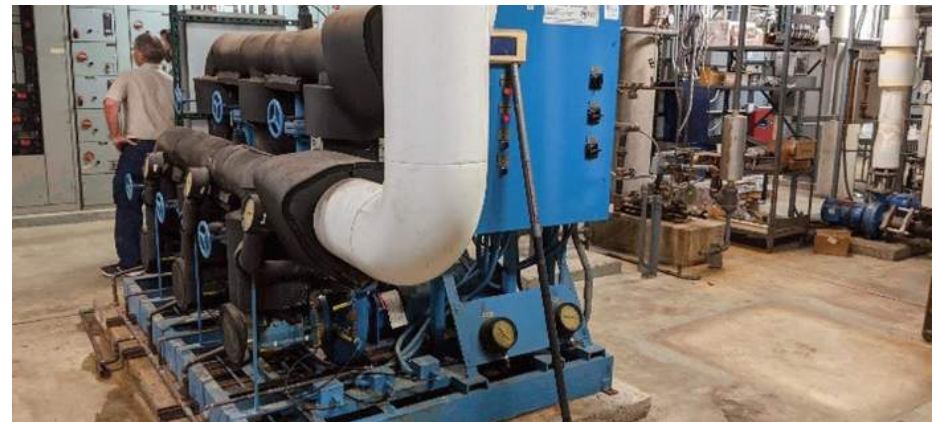
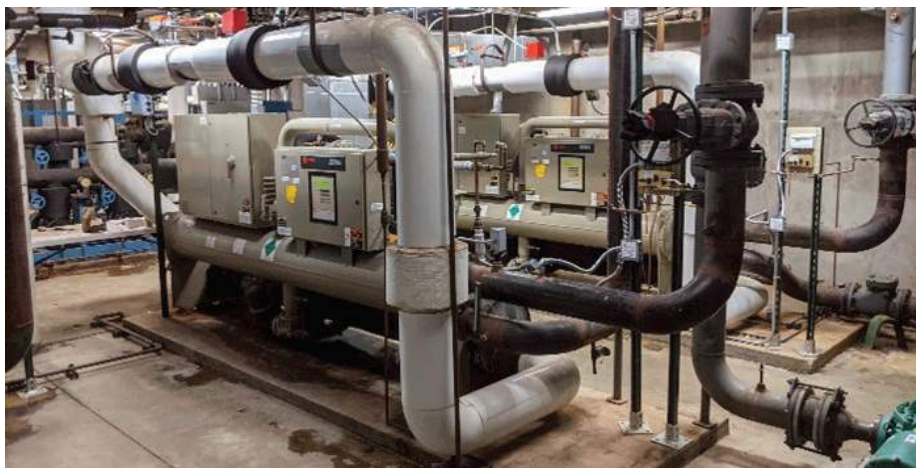
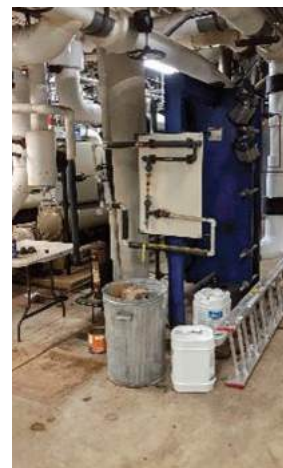
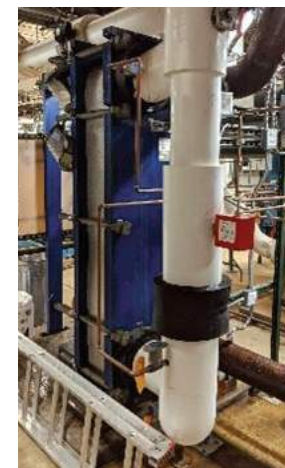
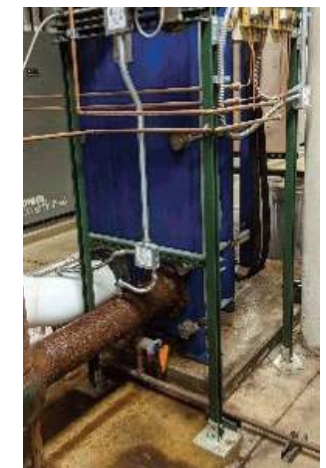
If the chilled water system met the diversified cooling load at the time of its installation, it is undersized now due to increased equipment loads. Cooling tower sizing appears to be consistent with chiller sizing. Supplemental cooling units have been added to the third-floor instrumentation room and in other locations to help offset this deficiency. The chilled water pump assembly has a redundant pump, but there is no redundancy for the condenser water pumps. A loss of condenser water pump CWP-1 will shut down chiller CH-1. A loss of condenser water pump CWP-2 shuts down chiller CH-2 or the heat exchanger if using free cooling (even though CWP-1 may still be operational).

While the condenser water piping is uninsulated in the basement, there is a significant amount of rust at the heat exchanger connections likely due to its proximity to outside air louver for central plant ventilation. We recommend that given the proximity of the heat exchanger to electrical gear, that the rusty pipe be replaced with new and insulated to prevent condensation in the future. Outdoor condenser water piping should also be insulated, and heat traced to protect against freezing. Note even with these recommendations, a loss of a chiller, cooling tower cell, or condenser water pump will limit system capacity which during peak demand periods will impact operations.

Images: Conditions of water-cooled chillers, cooling tower, plate & frame heat exchanger, and variable-speed chilled water pump skid.

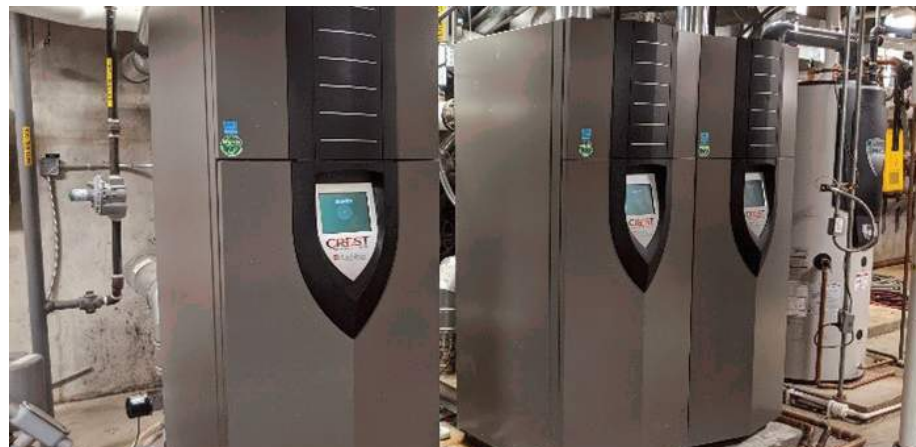
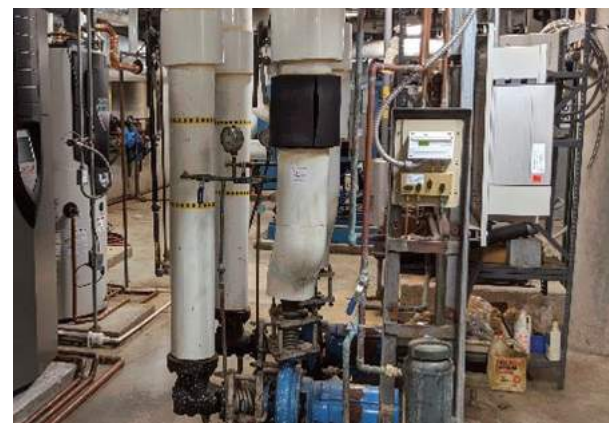
The original boiler was replaced with two boilers in 1998 but the existing heating water pumps remained (appears to be configured for redundant pumping at the time). The boilers have since been replaced recently (now total of three), though the heating water pumps appear to be original. Given the likely increased boiler capacity, we suspect that both heating water pumps will operate during peak periods to meet the heating load. The flue vents from the boilers are combined and vented to the outside through the existing boiler flue vent ducting.

Images: Gas-fired condensing boilers, boiler flue venting, and heating water pumps.

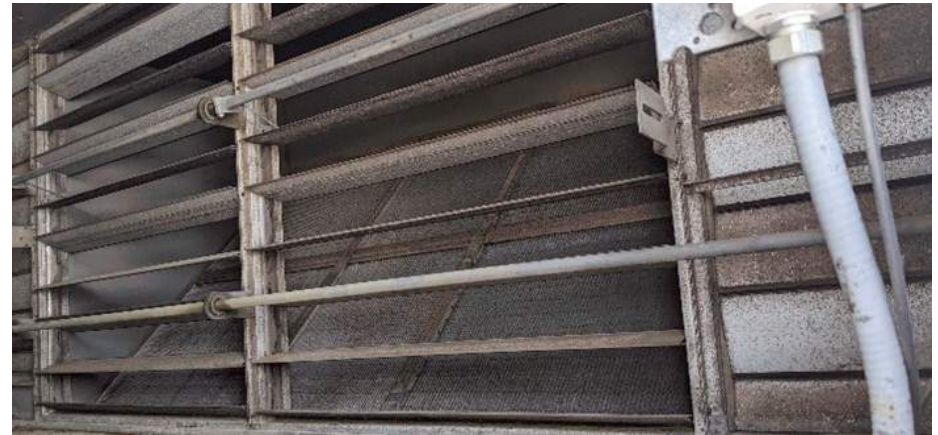
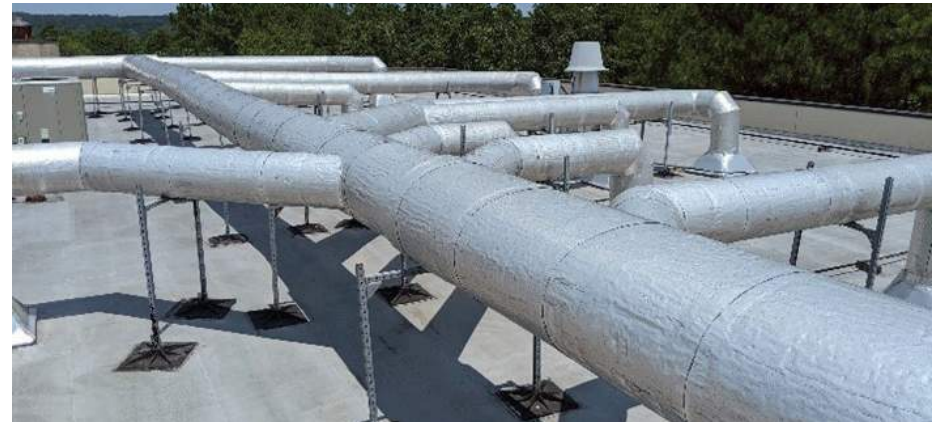
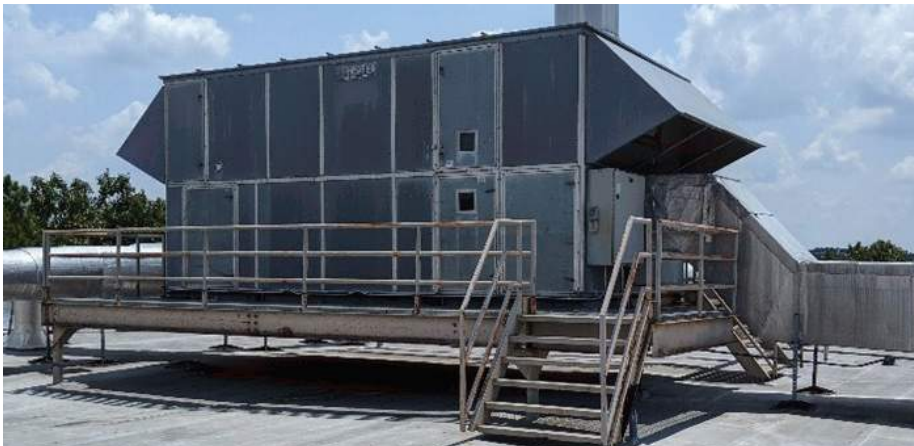
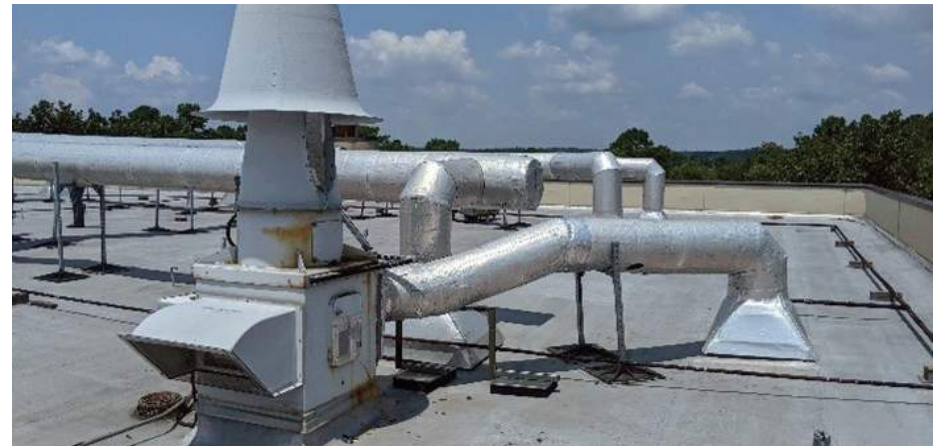
Images: Dedicated outside air heat recovery units with fixed metal plates and general exhaust ducted above the roof. Local fume hood exhaust fans with bypass outside air damper and dilution wind band.

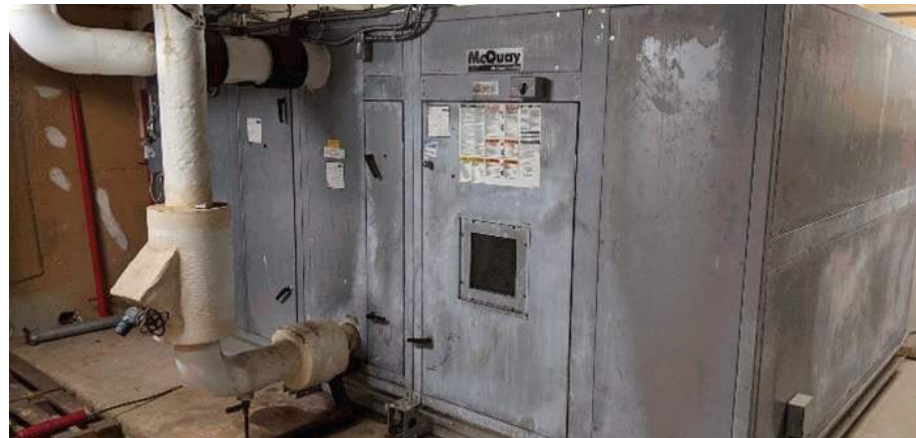
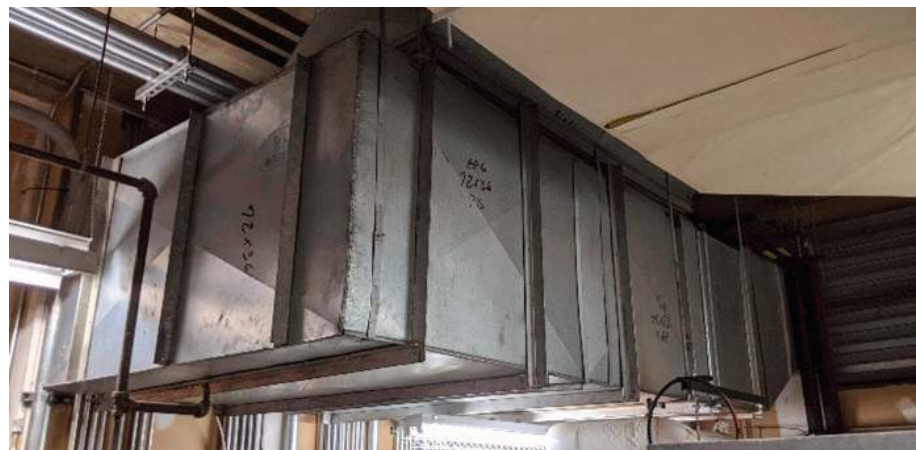
Images: Third-floor air-handling unit (1998) with tempered outside air chase from dedicated outside air heat recovery units.

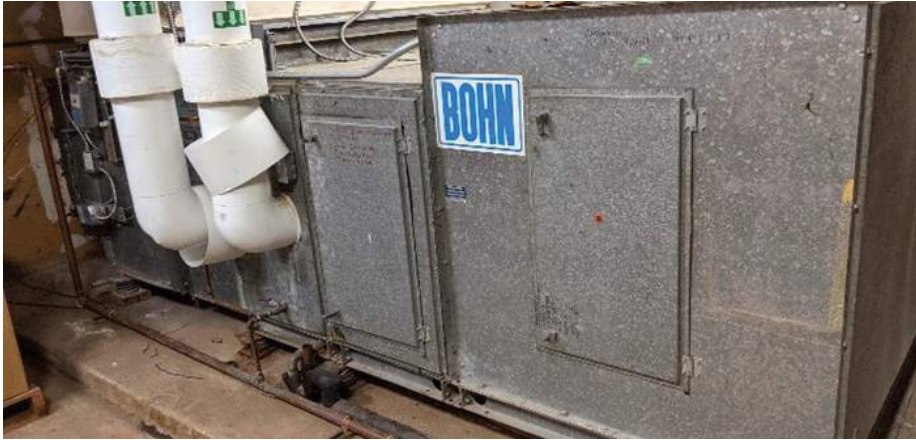
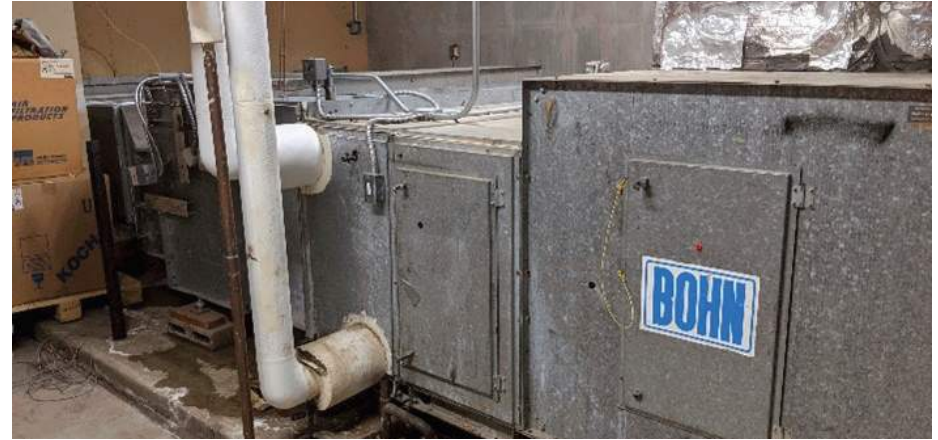
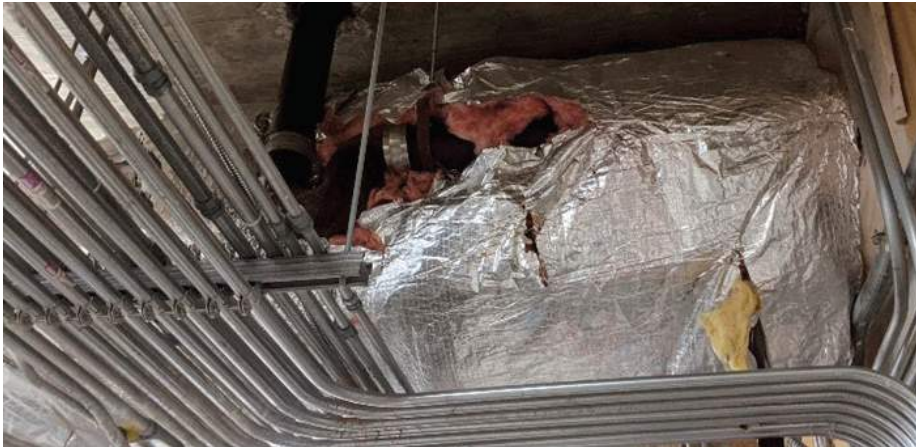
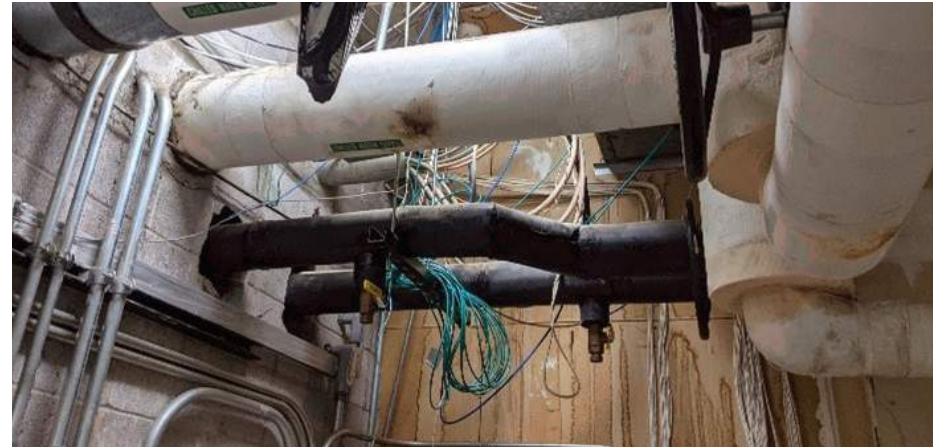
While still functional, we recommend the replacement of these air-handling units within the next five years. The unit casings are no longer entirely sealed and have undergone various repairs over the years, both to the casings and the spring vibration isolators. Drain pans were unable to be inspected at the time of the site visit. Duct insulation needs repair in numerous locations within the mechanical rooms. The mechanical rooms in general are not well sealed, with numerous penetrations in floors and walls.

Images: Commonly observed original air-handling unit with compromised supply duct insulation.

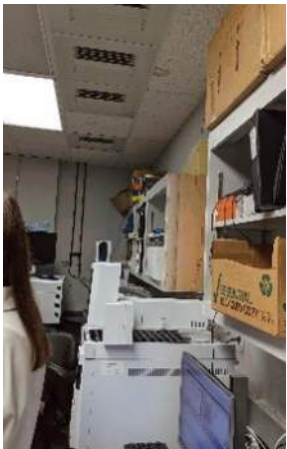
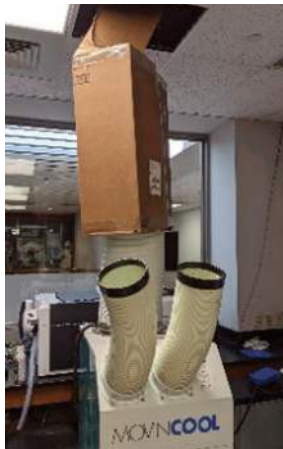
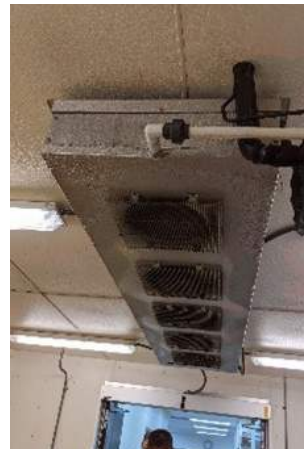
The building function and equipment used has changed from the original design. The air-handling unit serving the autopsy suite was likely installed nearly 40 years ago (drawings not available). In its current state the autopsy and decomp autopsy spaces likely meet the minimum 12 air changes per hour (ACH) required by code, but not much beyond that. The mixing-type air distribution strategy limits the effectiveness of the ventilation provided. The existing morgue dock where decedents are delivered has a unit heater to protect against freezing, but no active conditioning to eliminate moisture. A significant amount of outdoor humidity migrates into the coolers from this route and drips on the floor.

Images: Supplemental cooling unit for instrumentation lab with portable cooler. Walk-in cooler condensation resulting from adjacency to tempered loading area.

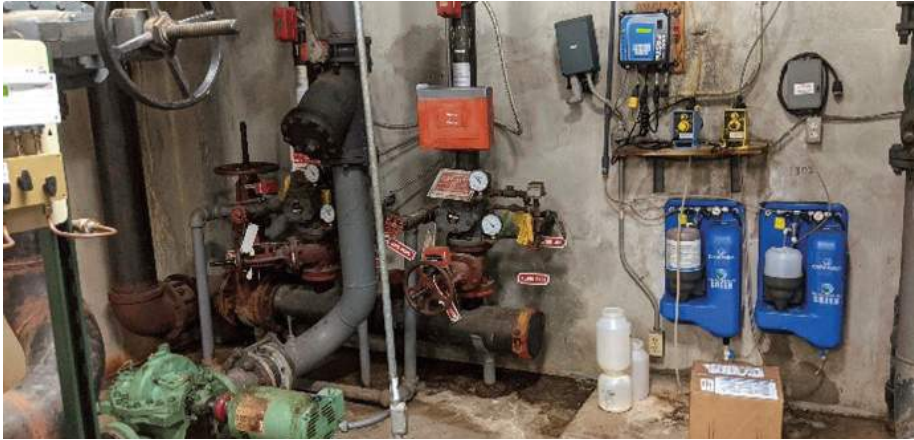
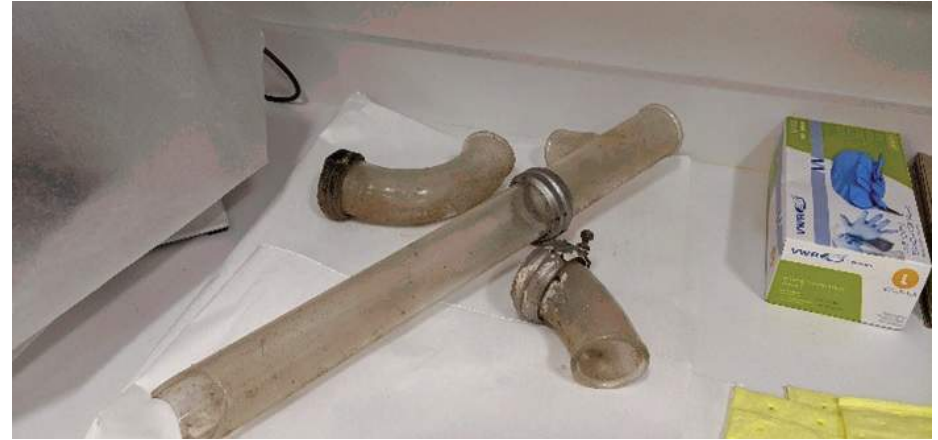
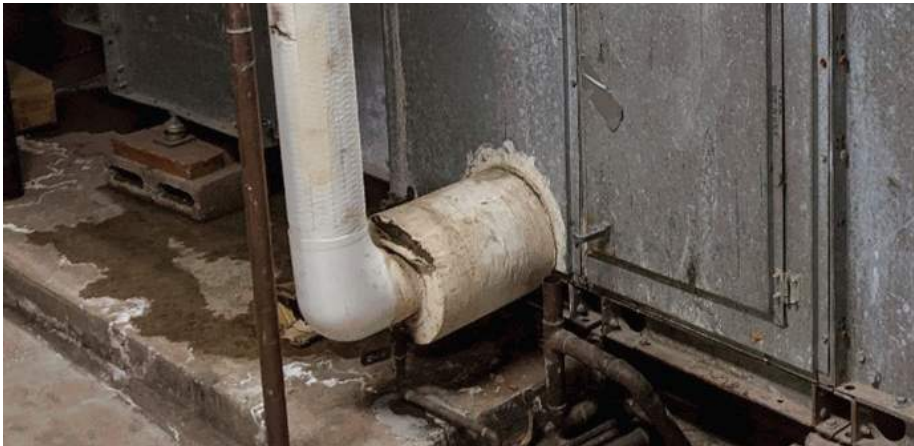
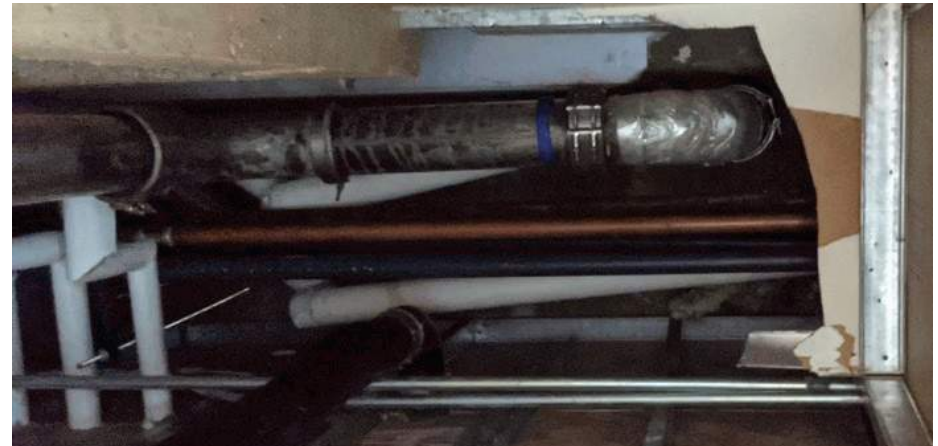
As the glass piping is fragile, we expect there will be more breaks and

Images: Gas-fired domestic hot water heater next to the heating water boilers with uninsulated domestic hot water piping.

Images: Portions of broken acid waste piping and piping repairs in shaft utilizing cast iron instead of glass.

The domestic hot water piping is copper. While there have been no reports of inadequate hot water, the domestic hot water system is missing insulation at the water heater. Note that the single domestic hot water heater and recirculation pump represent a single point of failure in the system. Given the recent installation, however, no modifications are recommended at this time other than to provide insulation for the uninsulated portions of the domestic hot water system in the basement.

repairs in the future when other work is being done in the area. Given the age of the system, we do not recommend replacement at this time unless it corresponded with a major renovation in the area. Where portions of the system are replaced, we recommend consideration for other more durable piping materials that meet plenum ratings (where applicable). Without treatment, at minimum a sampling port needs to be provided before connecting to the primary sanitary line so that the acid waste stream can be periodically inspected to ensure compliance with the no chemical usage policy.

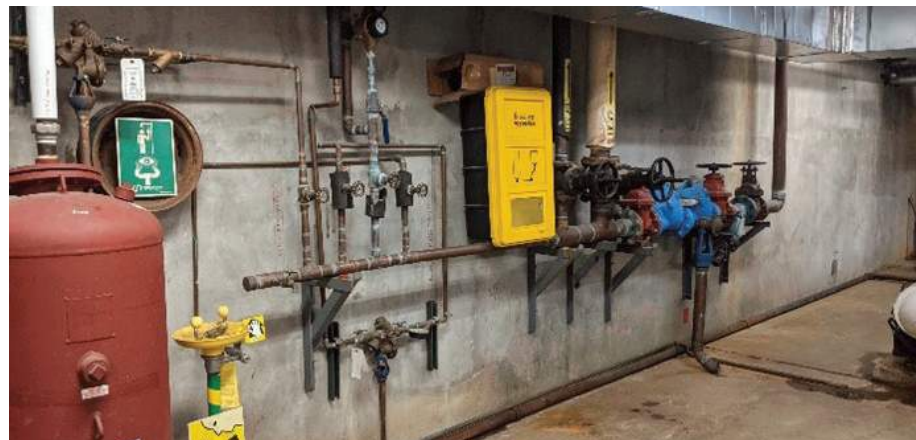
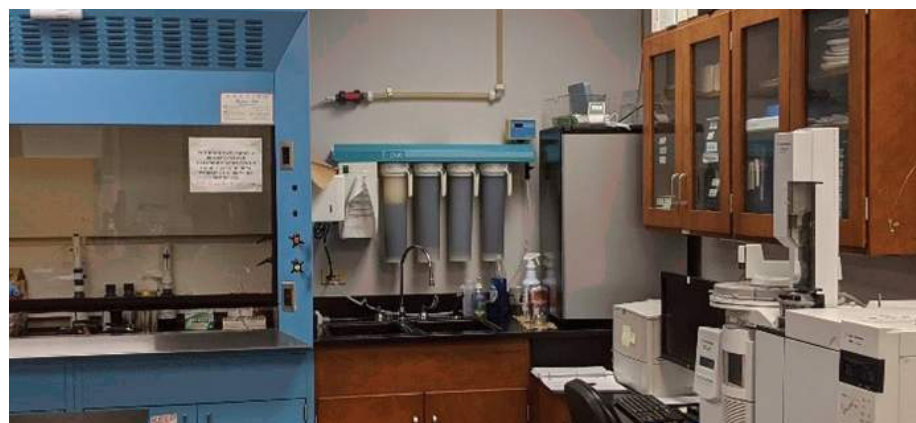
The domestic cold-water piping is copper. There is no separate industrial cold-water system. Laboratory plumbing faucets observed were the gooseneck type with no backflow prevention. While we did not observe the building pressure, there have been no reports of inadequate building pressure or flow. While calculations were not provided for the current installation, the system appears to be adequately sized for the current building program.

Images: Domestic cold-water entry in the basement central plant and a typical lab sink with gooseneck faucet but no vacuum breaker to protect domestic water source.

At a minimum we recommend vacuum breakers are added where missing at laboratory sinks to protect the domestic cold-water system from potential contamination.

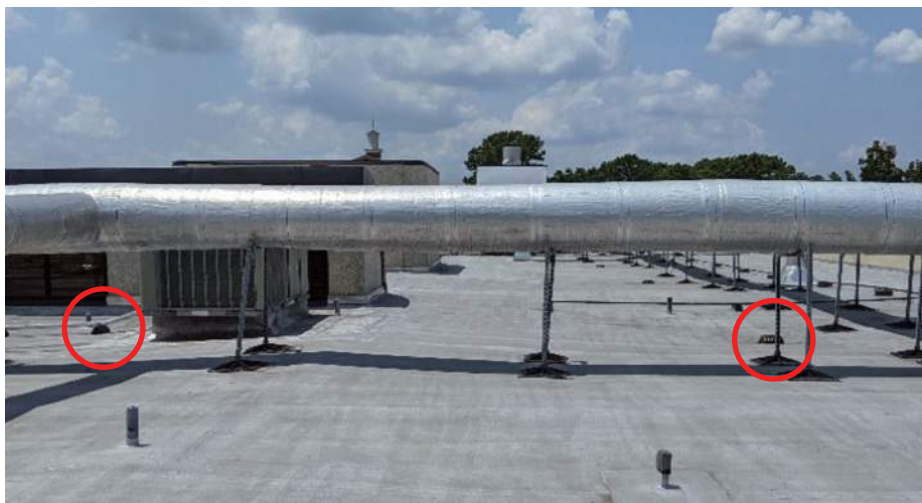
There is a concern that without the overflow drains that portions of the roof will be susceptible to standing water with a clogged strainer. The frequency of roof drains, however, appears to limit the amount of standing water with a clogged drain. There were no indications of water ponding or staining, indicating that the system is inspected regularly, and any debris removed.

Per the 2006 Arkansas Plumbing Code (based on the 2006 IPC) Section 1107.1, secondary drainage is required. Secondary (emergency) roof drains or scuppers shall be provided where the roof perimeter construction extends above the roof in such a manner that water will be entrapped if the primary drains allow buildup for any reason. If the intent is to remain at this facility, this deficiency will need to be corrected and secondary roof drains (or scuppers) added.

Image: Regular spacing of primary only roof drainage system (red circles) with no overflow drains or scuppers.

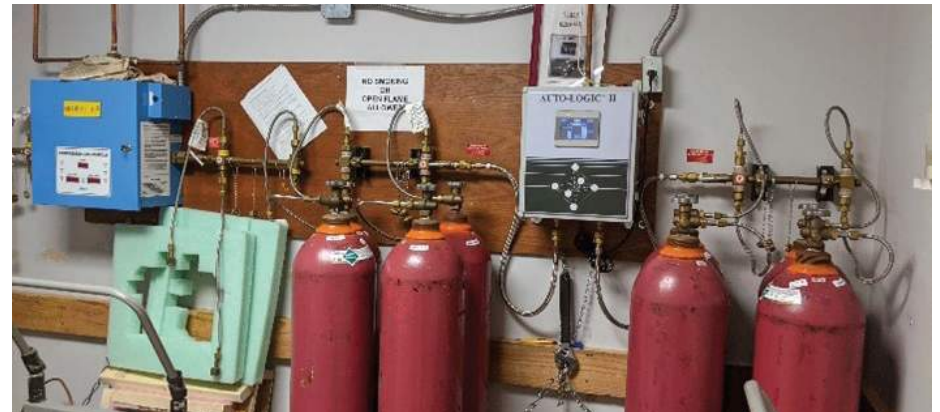
Image: Manifolded helium system. The medical air system (blue box) in the image is intended to be connected to local cylinders and is currently disconnected.

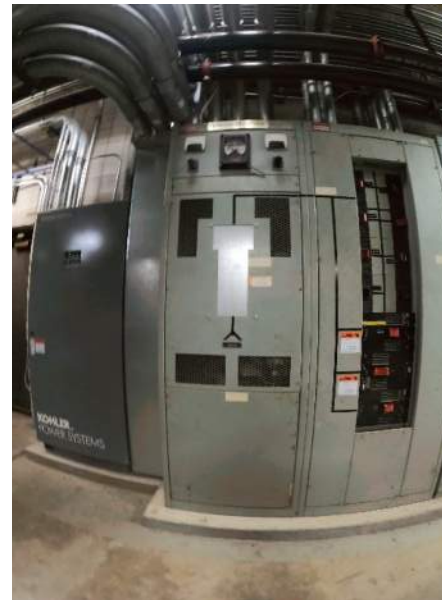
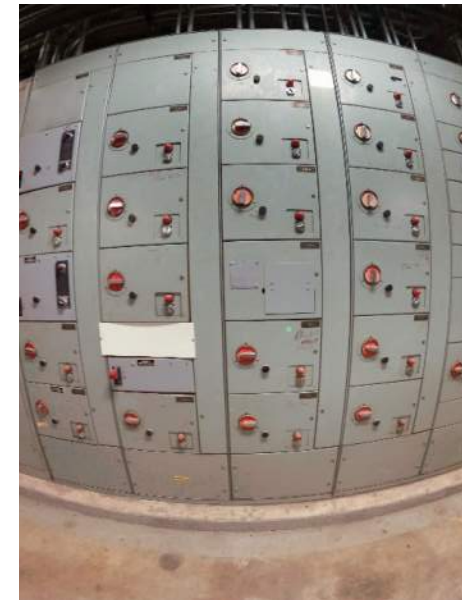
Images: Previous SES with metal panel cover installed (Left). MCC with plastic cover and standard junction box cover installed (Right).

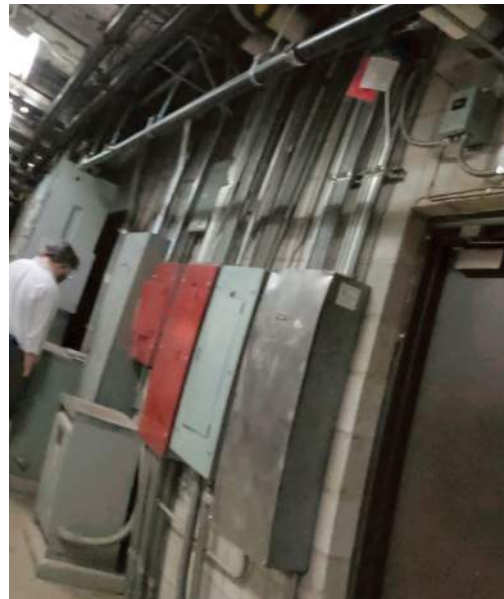
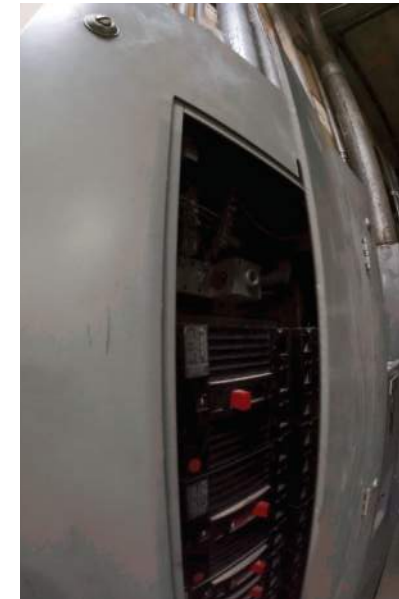
Images: Foreign systems passing through the overhead electrical equipment clearance zones (left). Missing interior cover of a distribution board, exposed live parts (right).

There is no space in the Electrical areas for future equipment and it is recommended that all the equipment with accessibility and clearance issues be relocated to a code compliant location. Additionally, because the equipment is located in the Mechanical space that has fluctuated in temperature and humidity over time due to maintenance and weather, it is recommended that the electrical equipment not longer reside in a space that is not temperature controlled. The ambient temperature in the mechanical spaces were higher than expected. It is recommended that all electrical closets be provided with appropriate ventilation. In some locations the exposure to mechanical equipment chemicals have corroded the metal conduit.

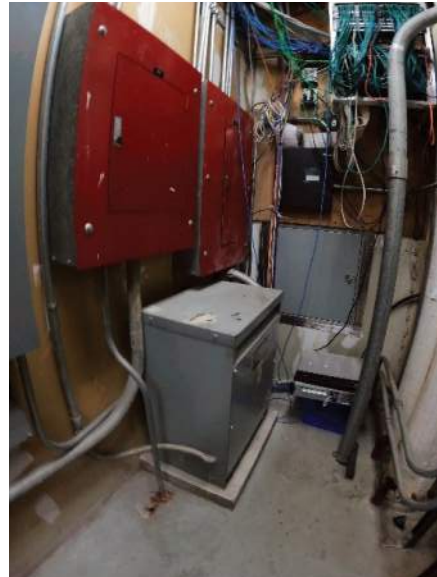
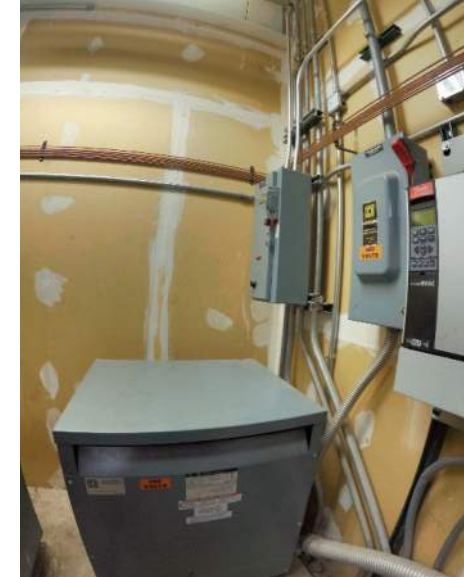
Images: Working space and clearance conflicts in the Electrical Area.

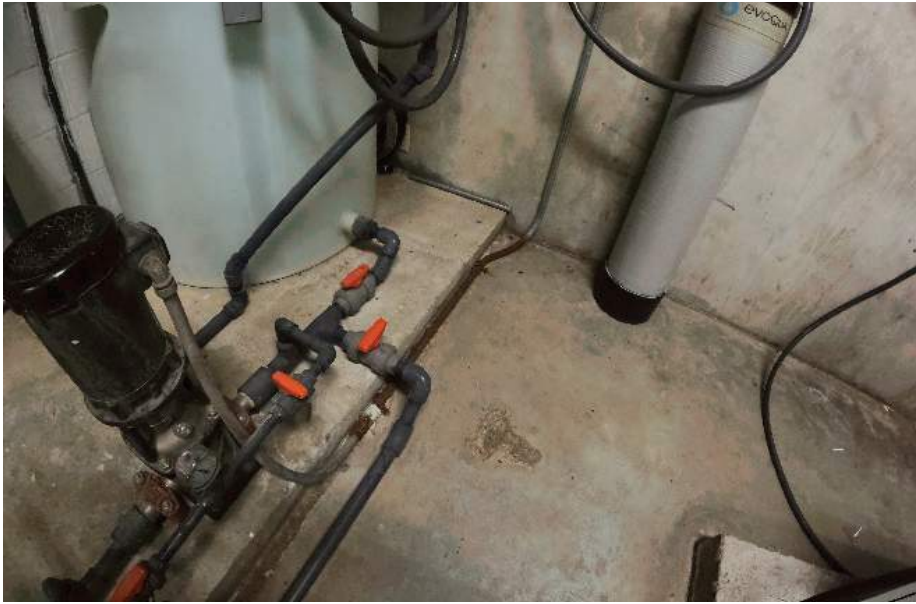
Image: Corroded metal conduit in main mechanical room.

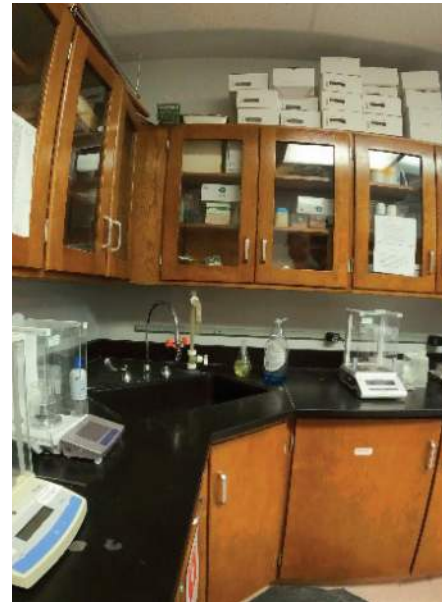
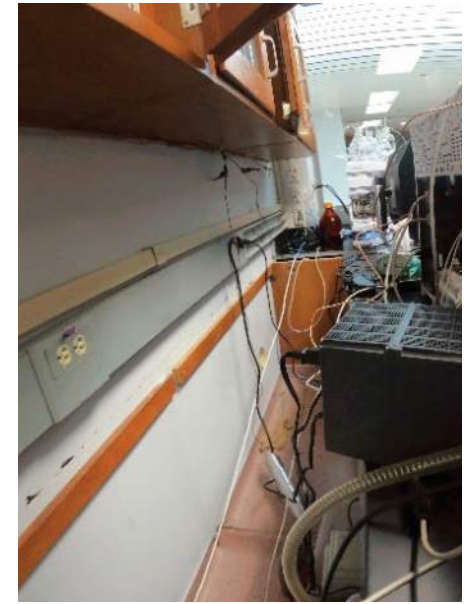
Images: Raceway behind sink (Left) and raceway at the end of its life (Right).

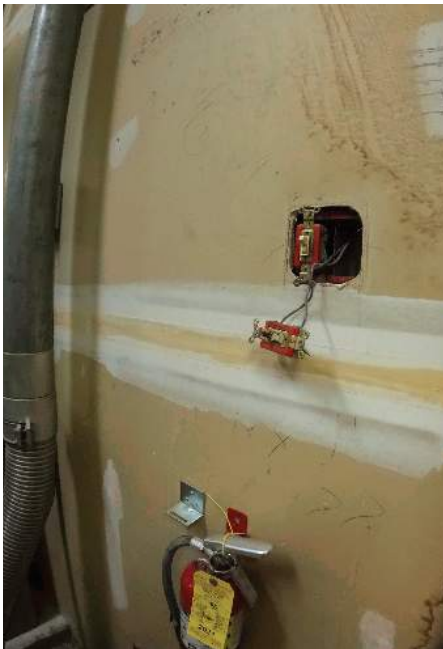
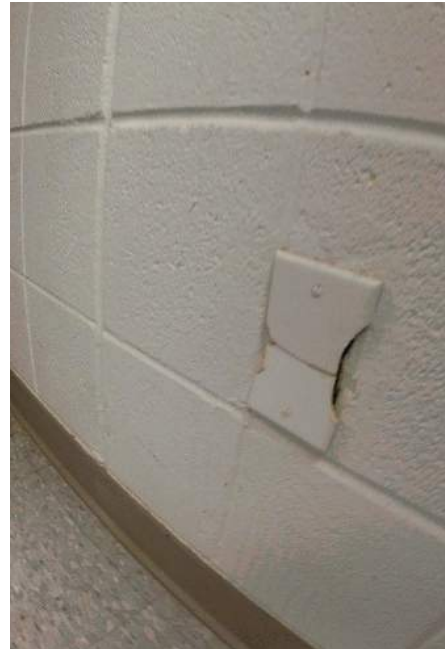
Images: Mechanical Room light switch with missing cover and exposed wires (Left).
Example of a damaged cover plate (Right).

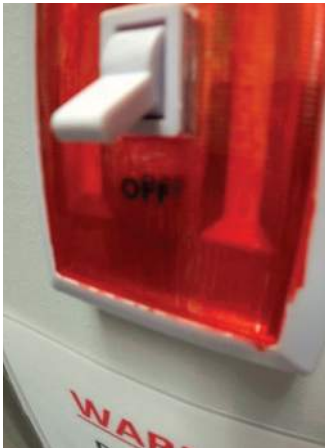
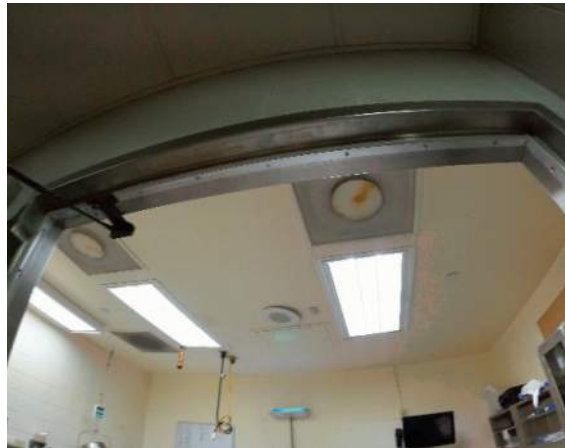
Specialty equipment appears to be functioning but often with limited working space and/or clearances. Occasionally there are limited safety measures in place for occupants and/or samples. For example, the bullet recovery tank is provided a residential quality sharpie painted battery power safety light that can be controlled from the corridor when in use.

Images: Sharpie painted warning light outside the bullet recovery tank (left).
Decomp Room ceiling configuration (right).

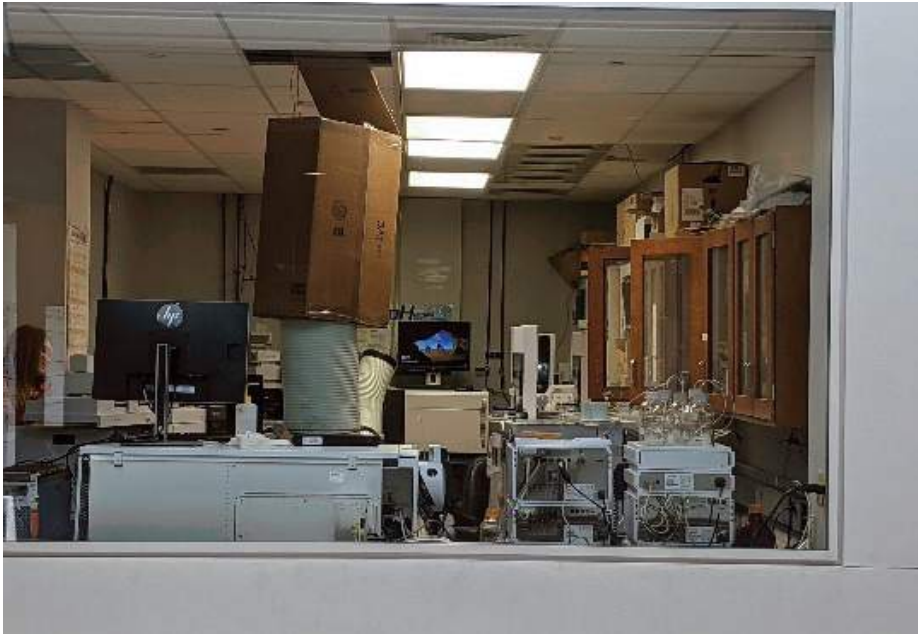
Image: Laboratory support lighting with portable cooling unit and heat rejection "duct".

Lighting in the open laboratories appeared to be at an adequate illumination level at the work plane. Lighting in the smaller laboratory support spaces are recommended to have increased light levels and more uniform lighting.

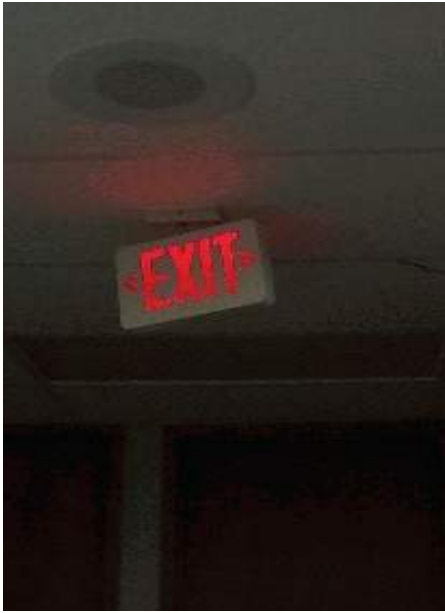
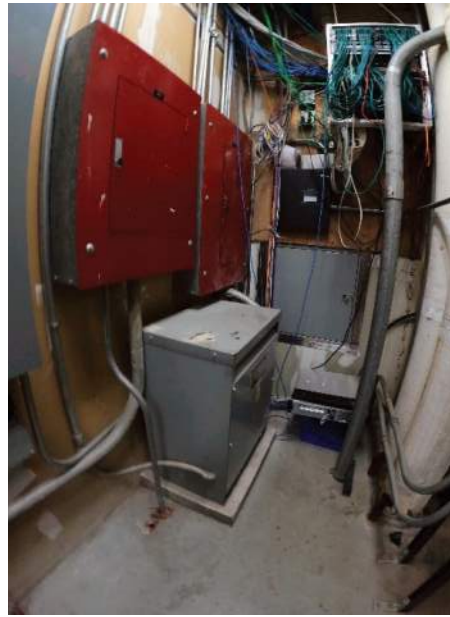
Images: Damaged exit sign(left) Server rack mounted with no working space at an unusual height in the mechanical room (right).
