FEASIBILITY STUDY

ARKANSAS STATE CRIME LAB

FINAL

09/30/2021

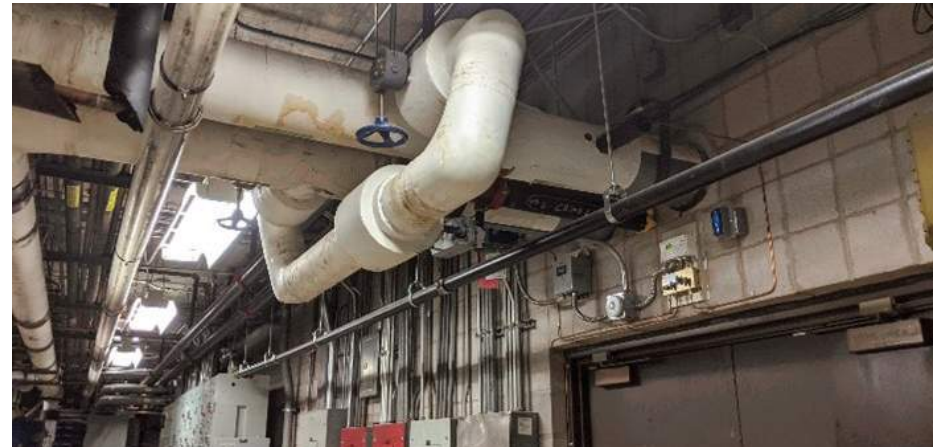
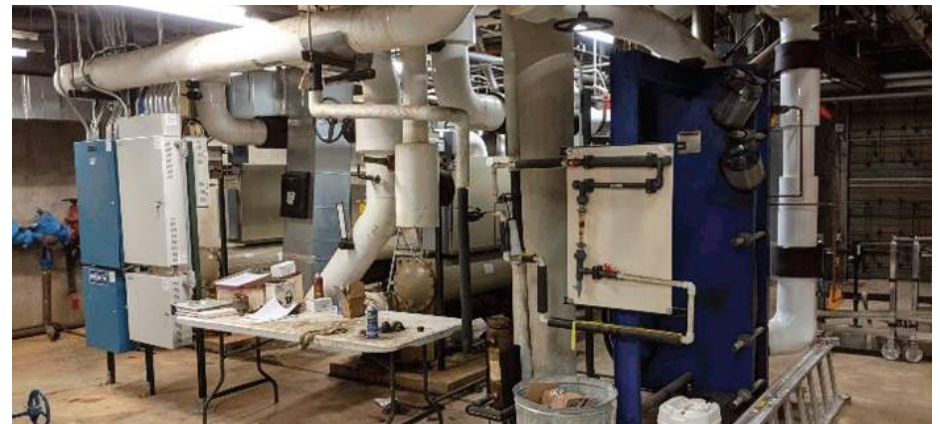
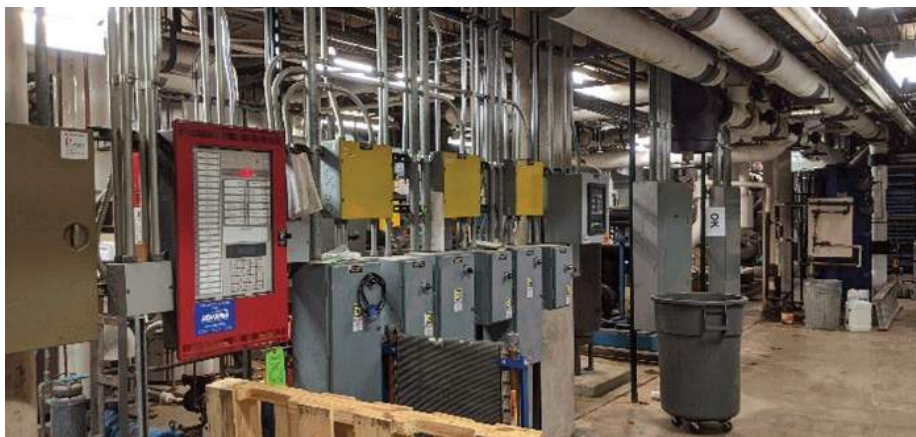
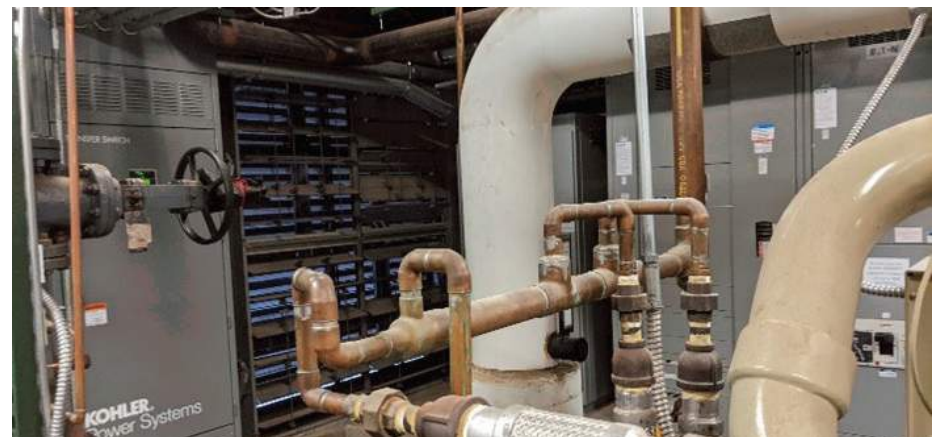
The typical building floor MEP rooms also do not meet the 2017 NEC clearances in all cases. Unlike the central plant, there is no water entry in these rooms and no natural gas piping. The basement MEP room has the potential for flooding, but all other mechanical rooms are above grade. A power outage stemming from an incident in one of these rooms also has a limited impact, specifically to the areas directly served from this room.

Images: Proximity issues of electrical gear and panels from mechanical, plumbing, and fire protection distribution in central plant.

- Significant water leak, fire sprinkler discharge, or flooding that raises water levels on the floor. Activation of a fire sprinkler head will generate an alarm, but a water leak from a broken pipe or flooding can go undetected. Consider adding moisture sensors near main electrical equipment pads to provide early warning of a potential problem.

- Significant natural gas leak. The natural gas is localized away from electrical gear and the room is ventilated, but a significant leak could go undetected. Adding a local detector near the boilers together with a 2-position gas solenoid valve and an emergency power off (EPO) switch at room entrance provides both an alert to elevated gas levels and a means to quickly shut down.

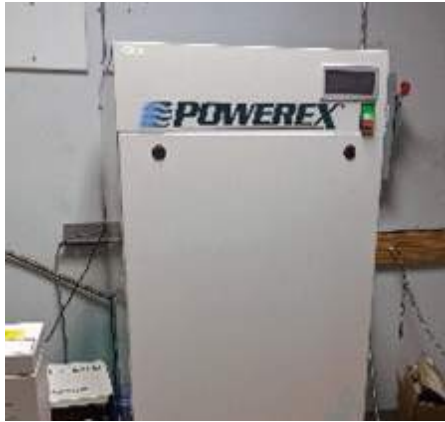
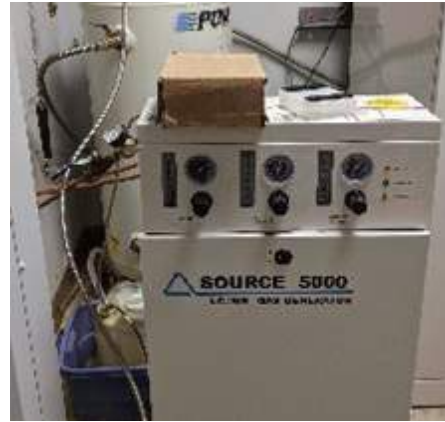
Images: local compressor supporting nitrogen generator

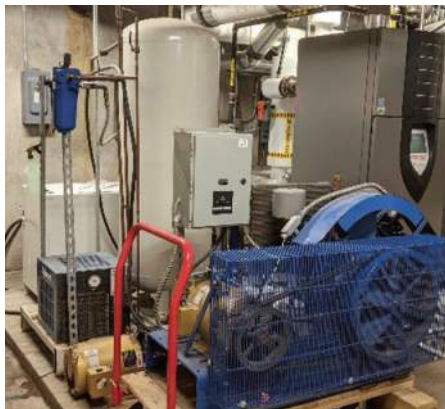
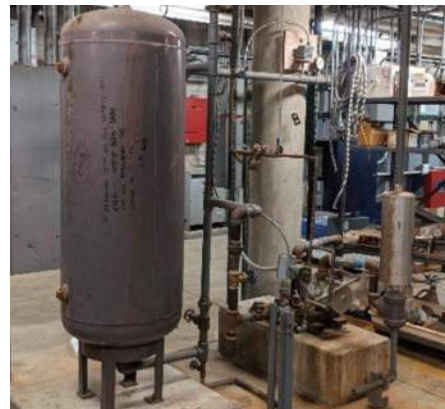
The process vacuum system pre-dates the 1998 laboratory renovation and consists of a vacuum tank and a single vacuum pump. 1-1/2-inch vacuum pipe is then extended up to the fume hoods in the laboratory floors. We were unable to inspect vacuum piping above the ceiling during the site visit. The installed system appears to be original, and it is unclear to the extent that the central vacuum system is utilized. No modifications are recommended at this time. If there is a major laboratory renovation in the future, we recommend evaluating the need and condition of the centralized system at that time.

Images: Central compressed air system in the basement (left), and central process vacuum system in the basement (right).

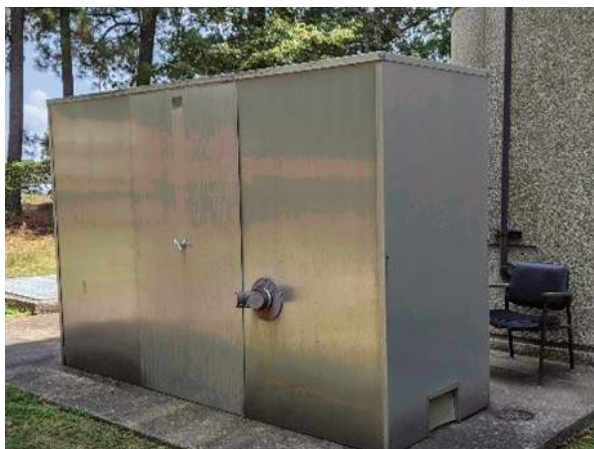
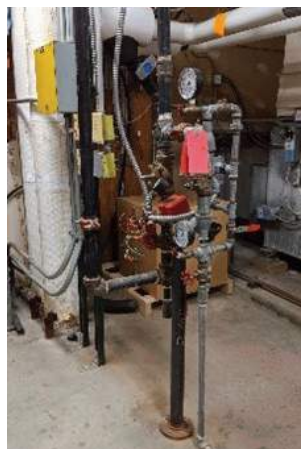
A challenge with the current two fire riser configuration is that while adequately sized for the 80,000 square foot building, the water flow at a given fire riser only indicates a side of the building on which the fire water is flowing, but not a specific floor. Fire department, security, or staff will need to determine the fire location with a given alarm. Note that there are no floor drains in the vicinity of the fire risers or at the locations of remote inspector tests (floor-by-floor mechanical rooms). With any maintenance or testing, water will spill to the floor on its way to the nearest floor drain.

Images: Aboveground backflow preventor in hot box (left), and remote inspector test in mechanical room with drain to floor (right).

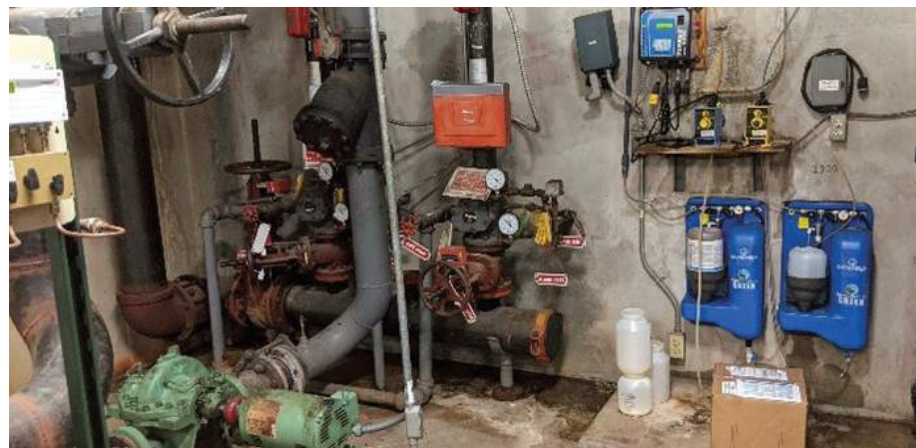
Image: Fire risers in back corner of central plant behind chillers and condenser water pump

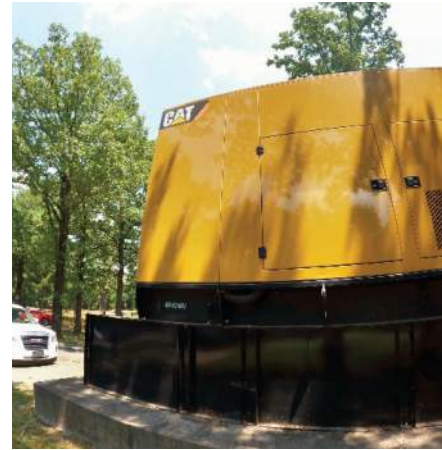
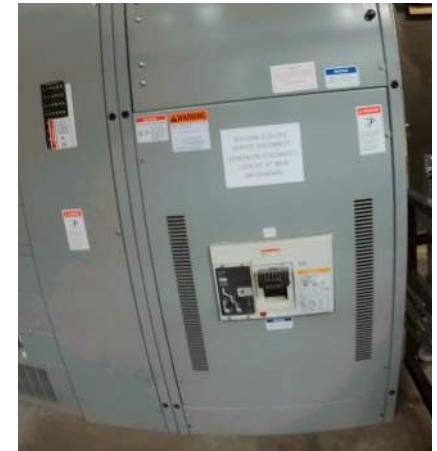
Images: Current generator (Left) and Disconnect sign (Right).

It is recommended that the system be labeled to reflect the existing conditions.

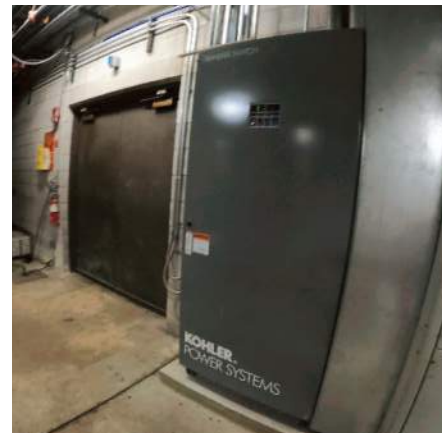
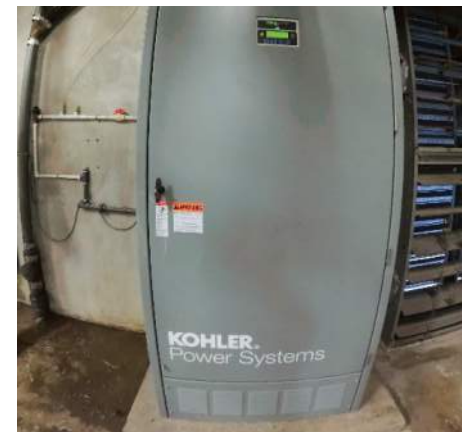
Images: Current ATS units (600A unit on the left).

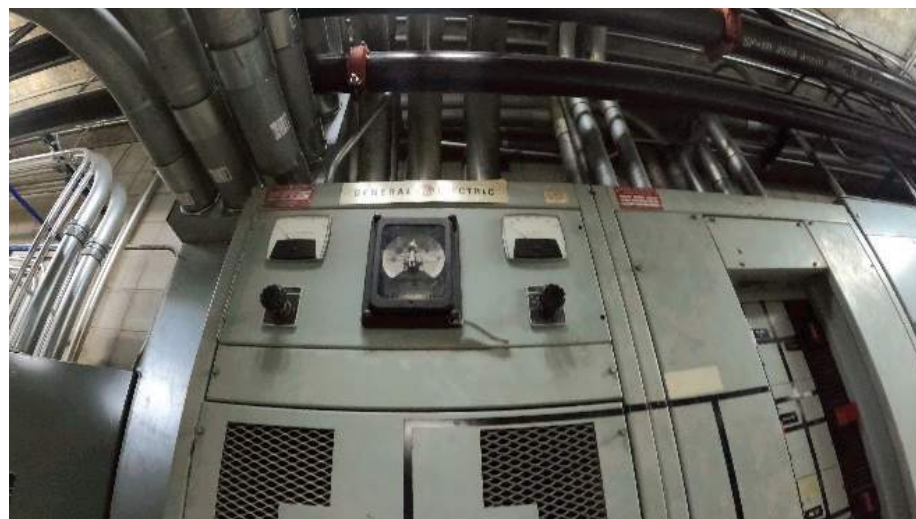
Load information was not available before the observation. The 12 month and 30 day Peak Demand can be requested by an Authorized Owner representative from EA Key account manager.

Image: Metering the original service equipment.

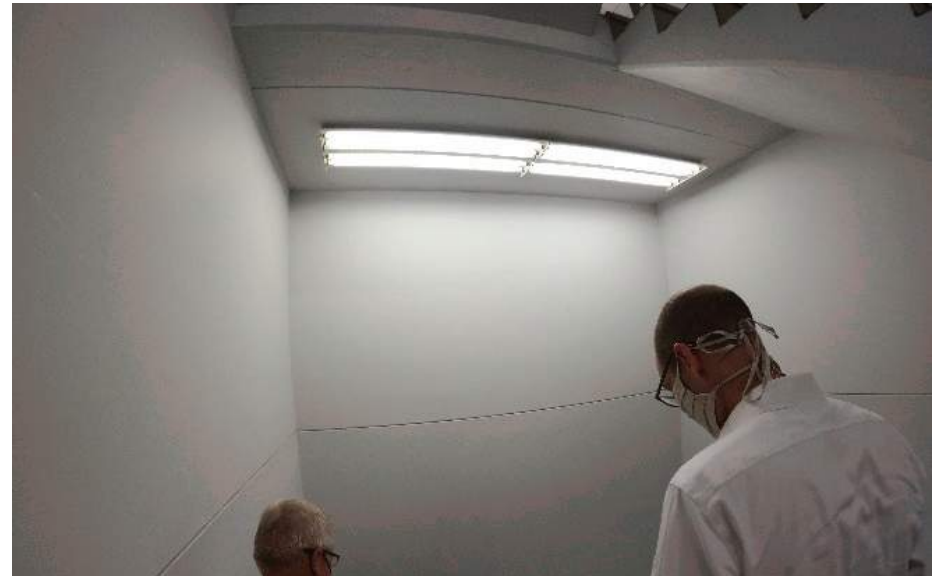
Lighting in the stairwells, except for the top landings, were appropriate for non-emergency use. The egress system was not tested during observation.

Image: Location of stairwell light fixture.

The locations of the light fixtures are in a difficult location to access. It would be recommended that to relocate the lighting in future renovations of the stairwell where a step-ladder could be used in order to prevent any injury while maintaining the light fixtures.

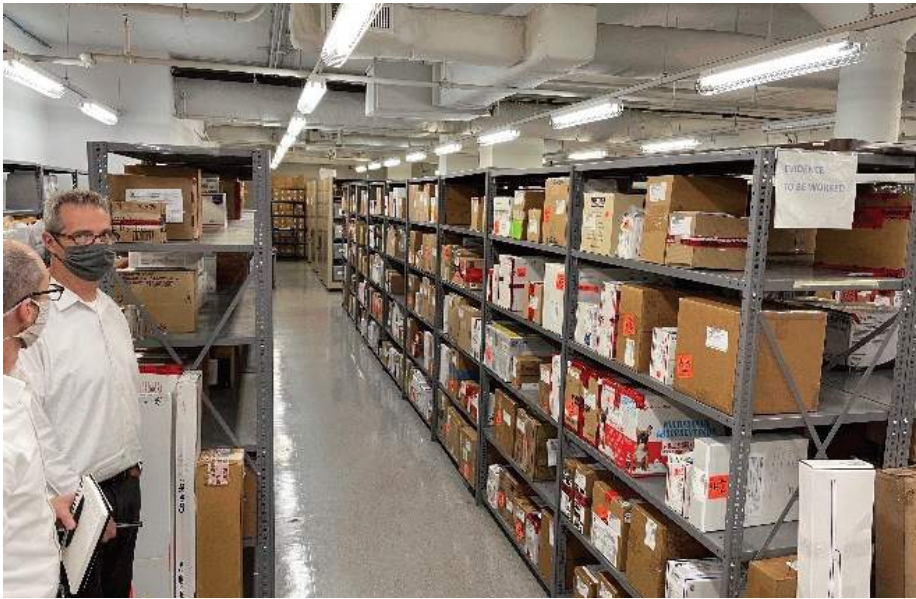
Lighting in the utility areas in inconsistent. There are locations where the lighting is appropriate and others where the lighting is minimal.

Image: Evidence Storage Lighting.

If there were to be a renovation, there would be an opportunity for energy and maintenance efficiency, as well as increased illumination by replacing the existing fixture locations with LED.

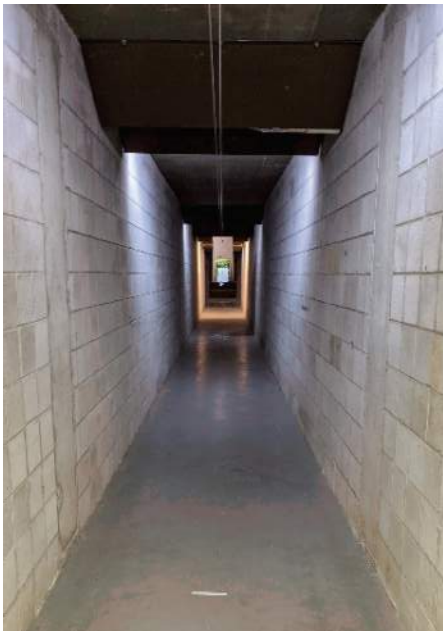
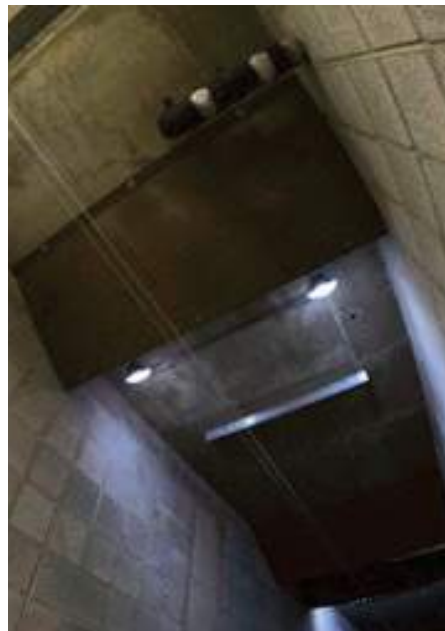
Bullet recovery lighting was not adequate and not uniform. This this area being a space of high safety concern it would be recommended to update the lighting and warning system for when a person is maintaining the firing area.

Images: Overall illumination (left) of firing range and lighting (right).

It is recommended due to safety concerns that interlocking warning lights be installed outside the bullet recovery tank room and the firing range with the ability to monitor the room remotely.

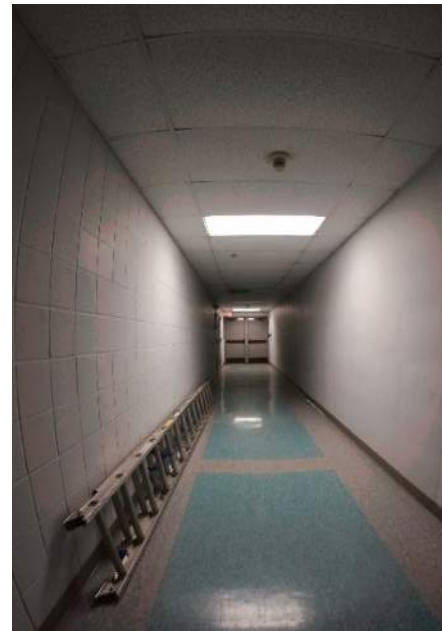
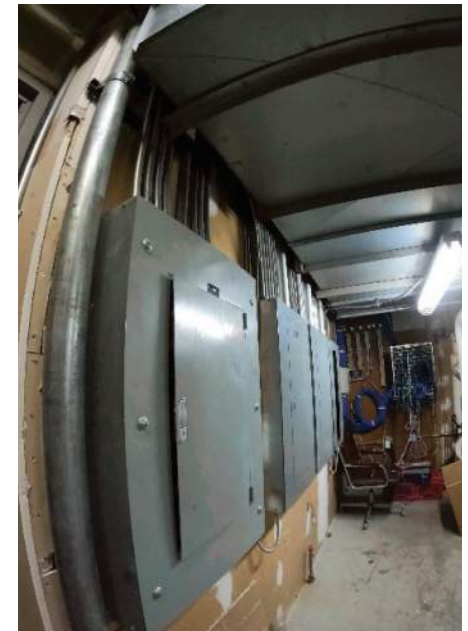
Images: Utility corridor lighting (left) and typical utility area lighting (right).

Throughout the building utility areas there are damage switches that require replacement.

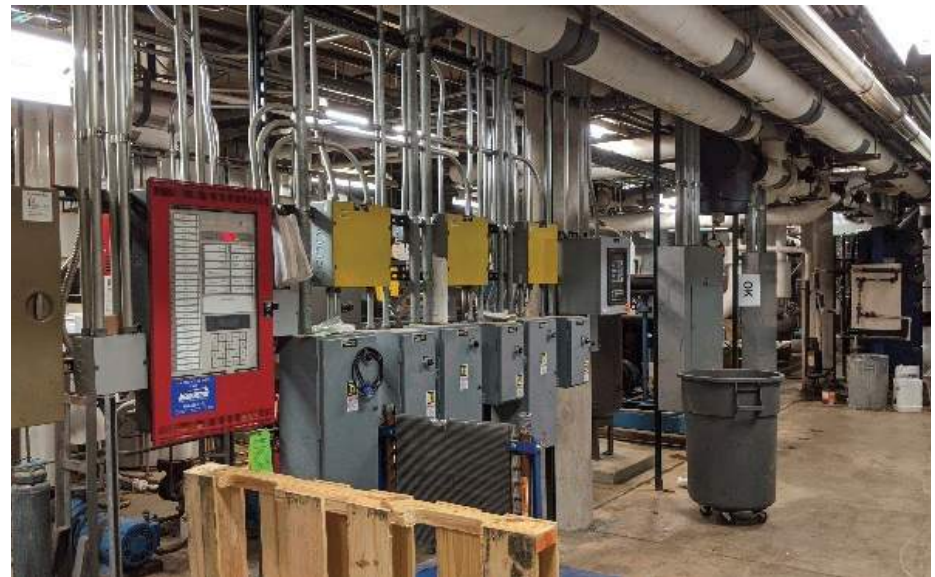
The Fire Alarm system appears to be a range of providers over the life of the building. The renovation system manufacturer was not documented in the as-built drawings. The system is installed in conduit. The FACP is in the Main Mechanical Room, which is not normally occupied or monitored by the security staff. It was not discovered during the site visit the location of a remote annunciator panel or if the FACP reports remotely.

Images: FACP in Mechanical Room.

No issues were reported during observation. For any future renovations a documented modification by a Fire Protection Engineer should be provided

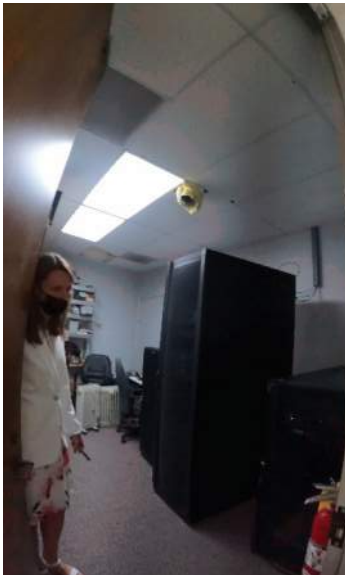
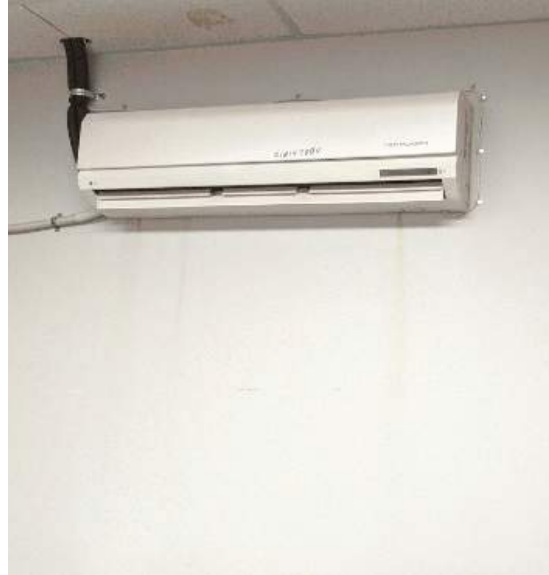
The current installation of the backbone data distribution equipment is not appropriate for the building type and is not provided the adequate quality of space expected for the equipment. There are locations where the racks are inaccessible or provided no working space. In addition, the mechanical rooms are not conditioned to the standard typically provided for the data equipment.

Throughout the life of the building the owner has re-purposed existing spaces to house data equipment that requires limited access or was not able to fit within the mechanical space. These closets have been provided local mechanical units to address the heat load, but as the system grows is expected to have continual ventilation issues. It is recommended that as a part of any future renovations space and exhaust planning for the future of these spaces be provided.

Images: Owner server room (left) and local conditioning unit (right).

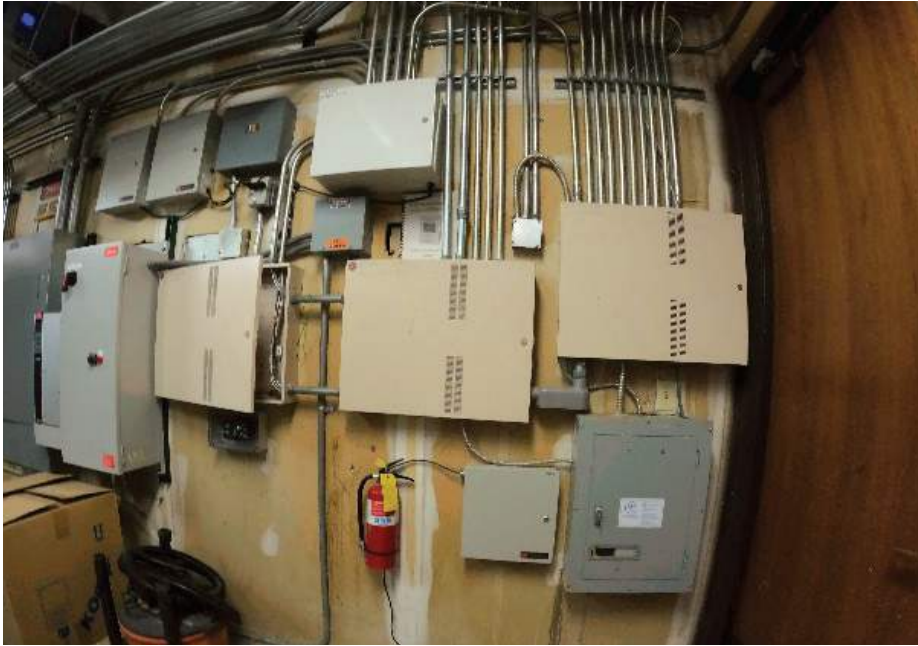
Security systems are housed in the mechanical rooms and appear to have a variety of providers over the lift of the building, including Secutron inc and Avigilon.

Access control provided throughout the building appropriately and security cameras appear to have been updated in the last 10 years. In certain locations wires and boxes are exposed and it would be beneficial to the security of the system to be concealed. It is recommended that additional cameras be provided to the firearms department for safety monitoring during testing.

Image: Security equipment in the mechanical room.
